1951-52 Johnson & Evinrude Gas Tanks

Article & Photos: Peter McDowell

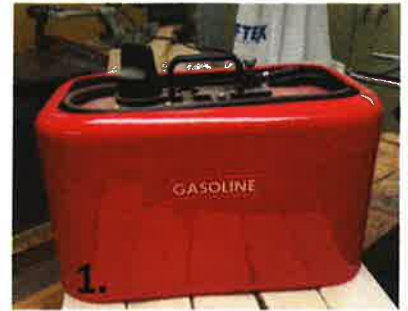
Picture #1 is of the 1951-52 Johnson gas tank. In disassembling the tank to restore it I came across something I didn't expect. I had worked on many gas tanks and was familiar with the valve assembly shown as parts 37-38-39 in the center of **picture #2**. This valve is there to prevent over pressure in the tank by allowing air to escape once the pressure has risen high enough to compress the spring and unseat the valve. This I expected to find. What I did not expect to find was two of them.

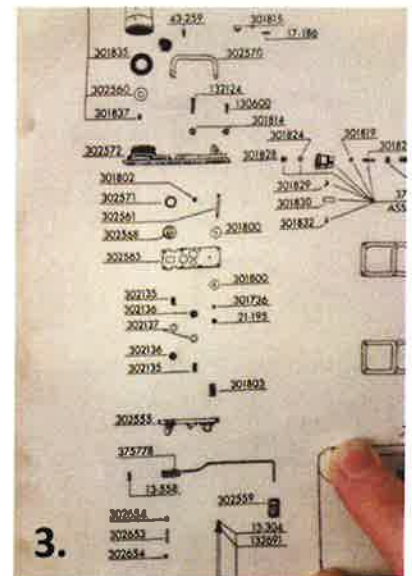
See **picture #3**. Parts # 302135-6-7 in the center to the left of the picture. Notice that they are oriented opposite to each other. The second valve, oriented opposite to the over pressure valve, is to prevent under pressure or vacuum in the tank. A tank with only a small amount of gas in it sitting in the hot sun, will see the air inside it expand because of the heat, unseating the valve and releasing the excess pressure. When the sun sets and the tank cools, the pressure inside the tank will drop. In this situation it can drop below ambient pressure and the tank can be crushed by this pressure differential. You might remember a science demonstration from public school. A gallon can with a small amount of water was placed on a heating element. After the water started to boil a lid was put on the can and it was removed from the heat and set aside. Class moved on and a few minutes later a loud noise was heard as the can was crushed by the ambient pressure.

The 1949-50 and 1953 and newer motors do not have this valve. I have seen quite a few gas tanks that suffered this under pressure situation. The bottom of the tank had buckled to the point of causing a hole in the bottom of the tank. The holes had been soldered closed or patched with epoxy.

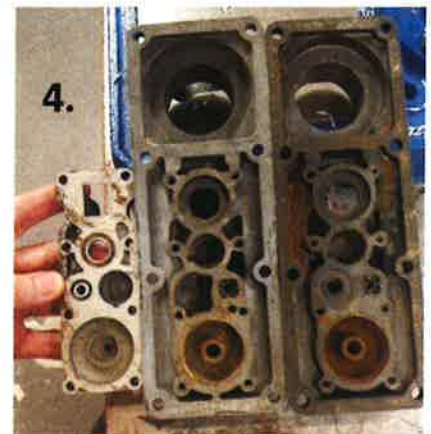
Picture #4 shows the fuel tank lower housing on the left. In the middle is the upper housing from a 1953-57 tank. On the right is the upper housing from a 1951-52 tank. You can see that the two upper housings are similar. At the bottom of the picture is the hole for the primer button. Just above that, on the left hand side of the housing is where the two pieces are different. This is the location for the under pressure valve in the 1951-52 tanks. On the 1953-57 housing this area has been cut out. Interestingly both have the same part number, 302572.
